Manhole Inspection Summary

Manhole # S35CC_022MH

Insp Date: **10/31/07 9:07 AM**

Location Address: **8 Eager street**

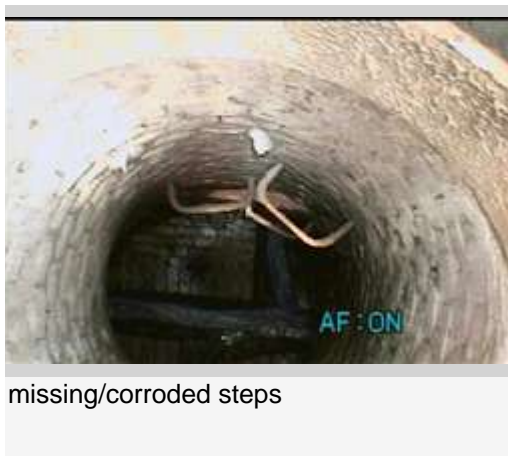
Defect 3

Count: **5** Missing: **1** ☒ **Corroded**

missing/corroded steps

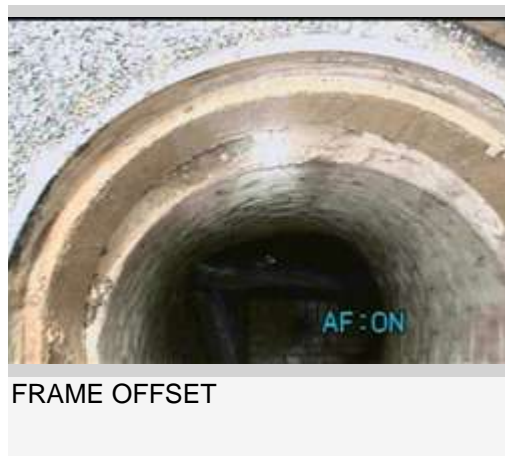
Defect 2

Offset: **2** (in.)

FRAME OFFSET

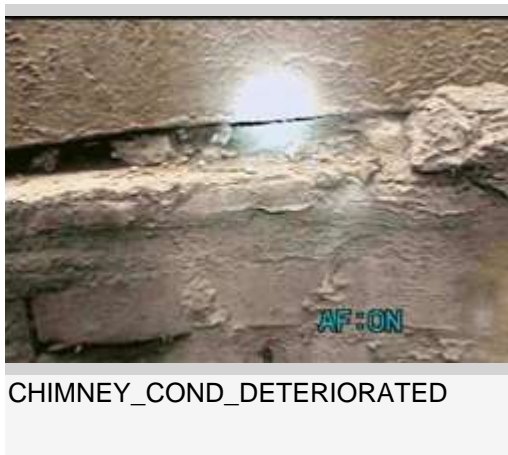
Defect 1

Condition: ☐ Sound ☐ Cracked ☐ Root Intrusion ☐ Loose Brick ☒ **Deteriorated**

CHIMNEY_COND_DETERIORATED

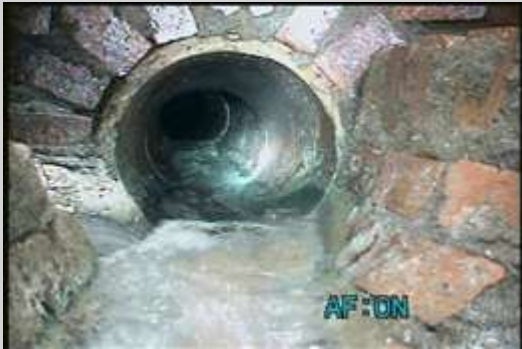
12 O'Clock Outflow

10 in. Circular Gravity Sewer
Pipe Out @ 12 O'Clock

Invert Depth: **10.93** (ft.) Flow Characteristics: **Fast**

Infiltration: **None** Pipe Seal Cond: **Unknown**

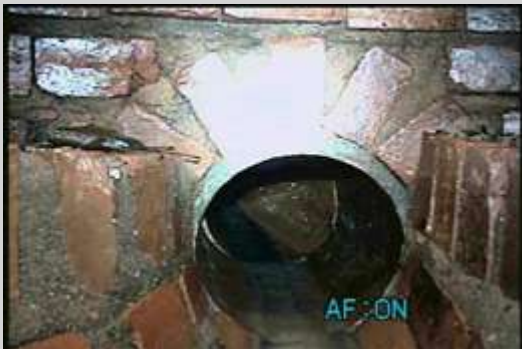
3 O'Clock Inflow

8 in. Circular Gravity Sewer
Pipe In @ 3 O'Clock

Invert Depth: **10.80** (ft.) Flow Characteristics: **Slow**

Infiltration: **None** Pipe Seal Cond: **Unknown**

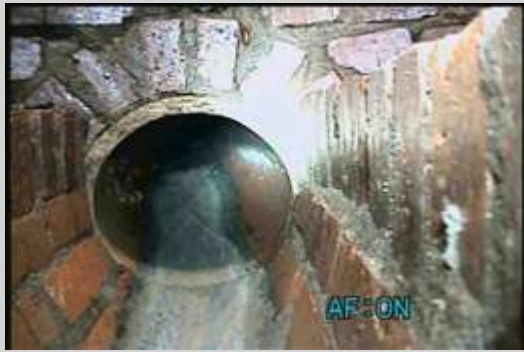
6 O'Clock Inflow

8 in. Circular Gravity Sewer

Pipe In @ 6 O'Clock

Invert Depth: **10.90** (ft.) Flow Characteristics: **Fast**

Infiltration: **None** Pipe Seal Cond: **Unknown**

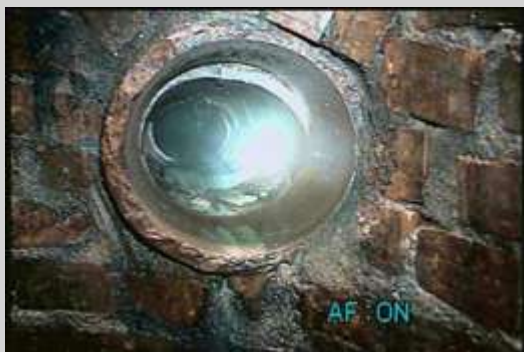
9 O'Clock Inflow

10 in. Circular Gravity Sewer

Pipe In @ 9 O'Clock

Invert Depth: **8.25** (ft.) Flow Characteristics: **Fast**

Infiltration: **None** Pipe Seal Cond: **Unknown**

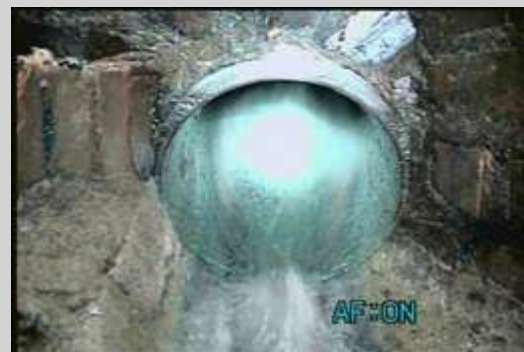
Drop In @ 9 O'Clock

Drop: **Outside Direct**

Inv Depth: **10.67** (ft.)

Drop Condition: **Open**
